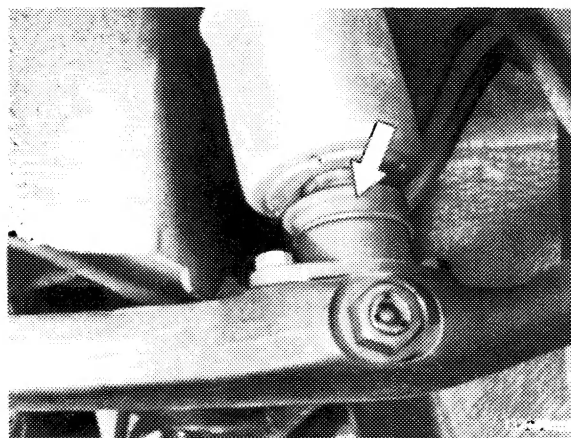
Ball joint on front axle

- Carefully check sealing and condition of rubber sleeves for ball joints on tube shocks of front and rear axle.

**Note:** In the event of a leaking rubber sleeve, replace respective joint immediately since penetrating dirt will result in early destruction of joint. The rubber sleeve alone cannot be replaced.
